Inspection Details

Report Commissioned By	[REDACTED]
Email Address	[REDACTED]
Date of Inspection	Wed October 9 2024
Time of Inspection	08:00 AM (12 GMT)
Inspection Conducted By	Jeremy Blackman
Present at time of inspection	Land owner's father
Agent Name	N/A
Purpose of Report	Subfloor damage inspection following recent leak
Weather at time of Inspection	Sunny (Recent Heavy Rain)
Main Cladding Type	N/A
Decade of Construction	1970's
Description of Site	Gentle Slope
Property Occupancy	N/A
Any known issues as advised by client?	Potential subfloor damage due to recent leak
Inspector Had Limited/No Access to	Inspection only of the subfloor requested, later access to the bathroom was granted for a water test on the leaking area.

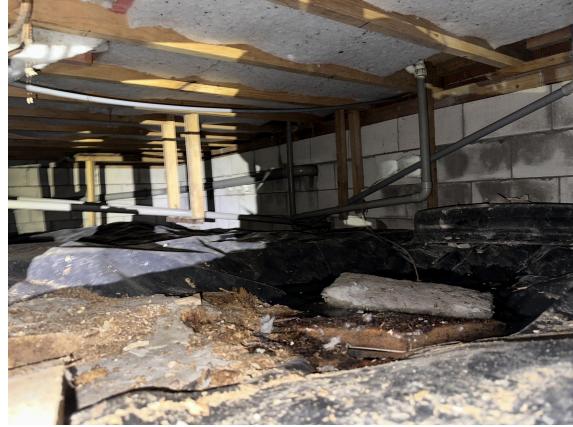
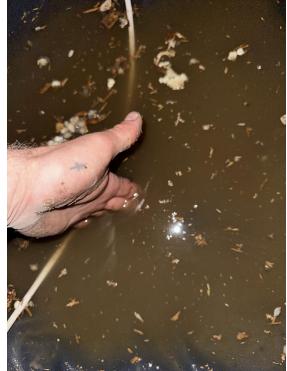
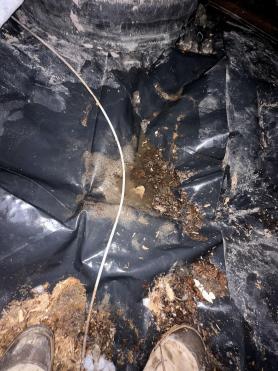
LOCATION	ISSUE IDENTIFIED	REMEDIAL ACTION REQUIRED	IMAGES
Where water pipe burst occurred	Water puddling on the damp proof membrane near the area of the water leak. This would've sorted itself with time, however I gave it a helping hand by draining the water out of the subfloor.	Issue dealt with during the inspection.

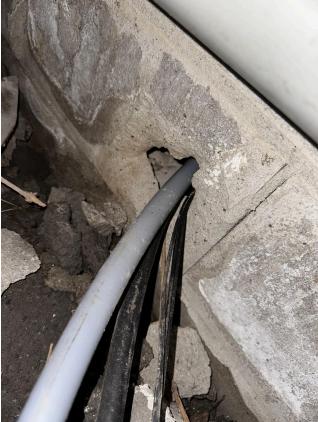
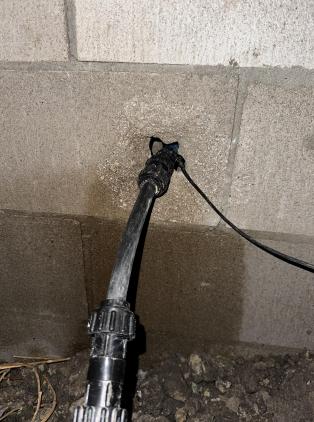
Waterpipe unsecured	The water main from the adjoining properties isn't secured under this subfloor, this is the proposed reason for the water pipe bursting. As water pressure goes on and off, water pipes move. This could cause the pipe to rub on the abrasive penetration through the blockwork. It's not against the plumbing code to have an unsecured water main, however it's likely the cause of this leak.	Our recommendation would be to secure the waterpipe up off the ground. Plus siliconing the opening in the blockwork to remove the possibility of the pipe rubbing on the abrasive stone.

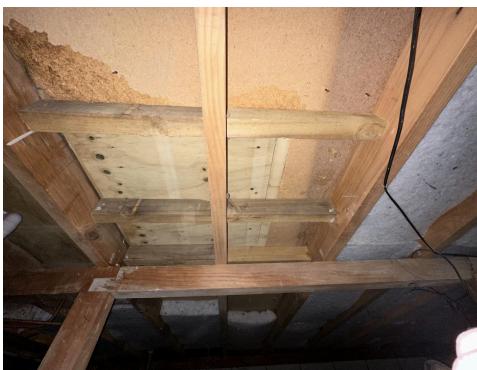
Missing insulation under the bathroom.	The bathroom floor was replaced at some point, the contractor who completed this job neglected to reinstate insulation under the bathroom area.	If this house is to be rented out, minimum R1.4 insulation under the bathroom would have to be installed to be healthy homes compliant.

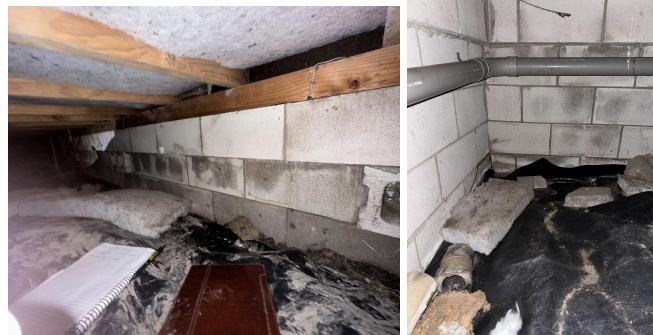
Water permeating through the blockwork foundation.

The paint on the outside of the blockwork is probably due to be maintained. This isn't an urgent repair, however by installing a sealant and new paint, the amount of water coming through the block will be greatly reduced. This will create a dryer subfloor space which will therefore warm up the house as there will be less rising damp.

Reseal and repaint blockwork foundation.

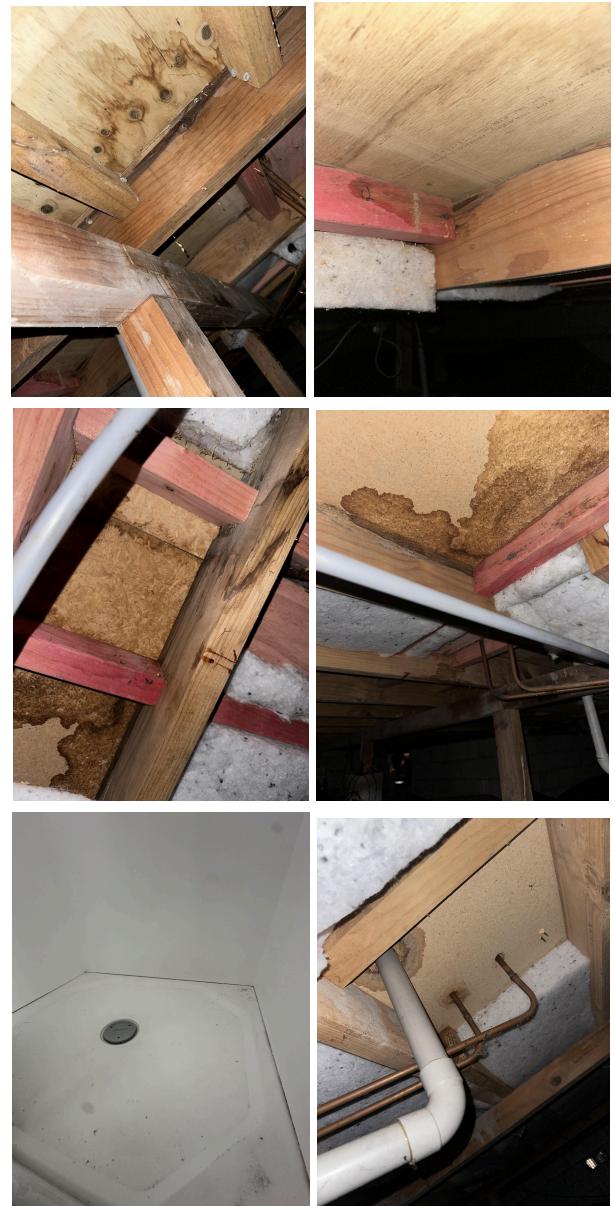
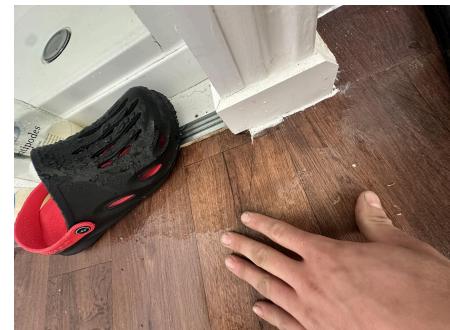
Water Leak in the bathroom.

During the inspection, I noticed water staining under the bathroom area. This staining was on the newer plywood flooring under the bathroom, the timber joists under the bathroom and the strandfloor around the bathroom.

This led me to conduct a 25 minute leak test on the bathroom area. In this short time frame the shower area started dripping into the subfloor. This is either due to a failure in the silicone around the shower liner, or from water being dragged out of the shower and onto the bathroom floor which isn't sealed well. This is something that should be remedied if the bathroom is being used as it will cause damage to the timber flooring and the subfloor framing with continued exposure to water.

If the bathroom isn't being used as your father has indicated, the issue isn't going to get any worse. However, this will be picked up by any pre purchase inspections done prior to you selling should this ever occur. No evidence of leaking under the bath, only the shower area.

Flooring recommended to be replaced to give the bathroom floor a flat surface. Shower silicone repairs and subsequent leak testing recommended. Vinyl would be a low cost option to improve the water resistance of the floor.

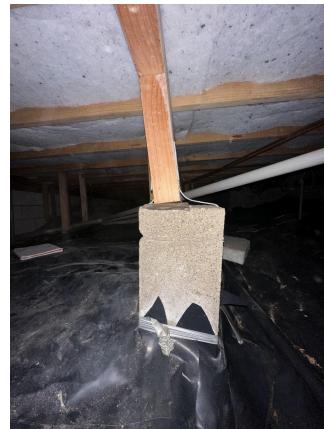
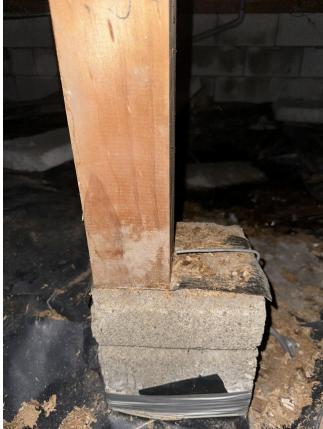
Two piles compromised

One pile footing has fallen over due to the soil next to the floating being removed. This isn't going to affect your house in the short term, however it should be fixed in the near future to reduce stress on the timber supporting this section of the floor.

One pile's mechanical fixing has been removed and the pile is sitting on the edge of the footing. This isn't as much of a concern compared to the pile that's fallen over, however it is recommended that this gets fixed when the other pile is being done.

Two new piles and footings recommended. Rough approx costings for a job of this size is \$1500 - \$2500
